# Errata Sheet

## YTM32B1HA0

This document details the silicon errata known at the time of publication for the YTM32B1HA0 device. For additional information, please see YTM32B1HA0 Reference Manual or Data sheet.

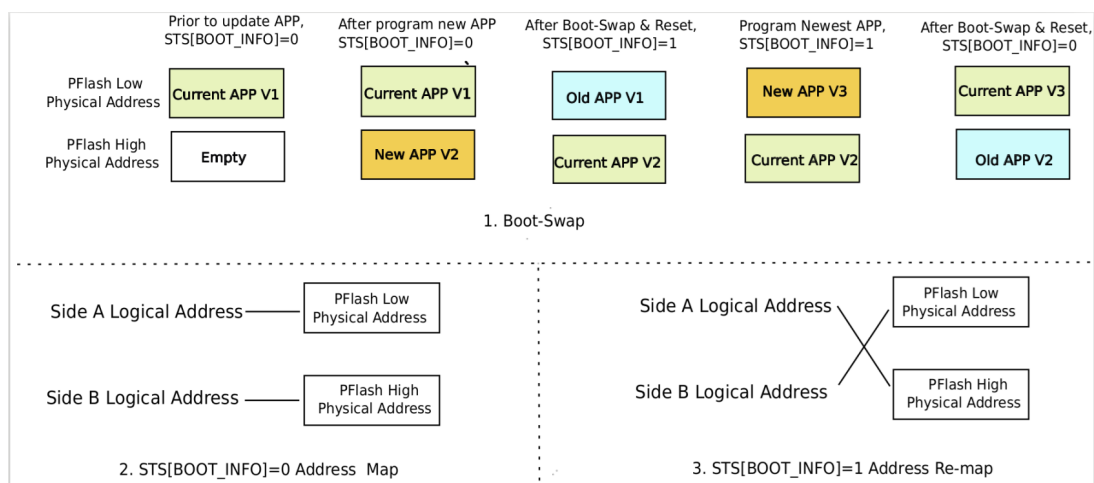
Figure 1: EFM update application code On-The-Air

Analysis of EFM hardware operation failure when “Execute the EFM BOOT\_SWAP command”:

- When EFM receives a BOOT\_SWAP command with STS[BOOT\_INFO]=0, it programs SWAP\_TAG (0x5A5A5A5A5A5A5A5A) to the first three addresses of the BOOT\_NVR sector in sequence. If the MCU power off while programming SWAP\_TAGS, the number of successfully written SWAP\_TAGS may be less than two. After MCU reset, STS[BOOT\_INFO] remains 0, logical address remapping failed, the Flash physical array containing the new version application is still maps to Side B, and the MCU executes the old version application from Side A by default. This application code update flow failed. Even if the update process is restarted from steps 1 to 4, when it reaches step 3 to program SWAP\_TAG, the first three addresses of the BOOT\_NVR sector are not empty, and the hardware will refuse to execute the Flash program operation, so the MCU cannot update the application in PFlash anymore.

- When EFM receives a BOOT\_SWAP command with STS[BOOT\_INFO]=1, it erases the BOOT\_NVR sector. If the MCU power off during the erasure of the BOOT\_NVR sector, the first three addresses of BOOT\_NVR may not be completely erased, yet at least two addresses no longer equal SWAP\_TAG. After MCU reset, STS[BOOT\_INFO]=0, the Flash physical array containing the newest version application is mapped to Side A, and the MCU executes the application from Side A by default. This application code version updates successfully. However, the next time a new version of the application is detected, the update process needs to program SWAP\_TAGS, it will find that the first three addresses of the BOOT\_NVR sector are not empty, and the hardware will refuse to execute the Flash program operation, so the MCU cannot update the application in PFlash anymore.

1. Erase PFlash Side B.
  2. Program the new version of the application to Side B.
  3. Execute the EFM BOOT\_SWAP command.
    1. In the execution of BOOT\_SWAP command, wait for EFM STS[DONE] to be set. Check the EFM STS[FAIL] register. If STS[FAIL]=1, the software needs to perform the following operations:

2. First, write 0x484130 to the EFM register FAC\_KEY (EFM offset address 0x304), and read back FAC\_KEY equals 0x80000000.
      3. Use the ERASE\_SECTOR command to erase the BOOT\_NVR sector (starting address 0x10003800, sector size 2KB).

4. Read EFM STS[BOOT\_INFO], if STS[BOOT\_INFO]=0, execute the BOOT\_SWAP command again.
      5. Write 0x0 to the FAC\_KEY register, and read back FAC\_KEY equals 0.

4. Reset the MCU, at this point, the physical Flash modules corresponding to the A/B Side logical addresses are swapped, and the Flash module containing the new version of the application is remapped to Side A.

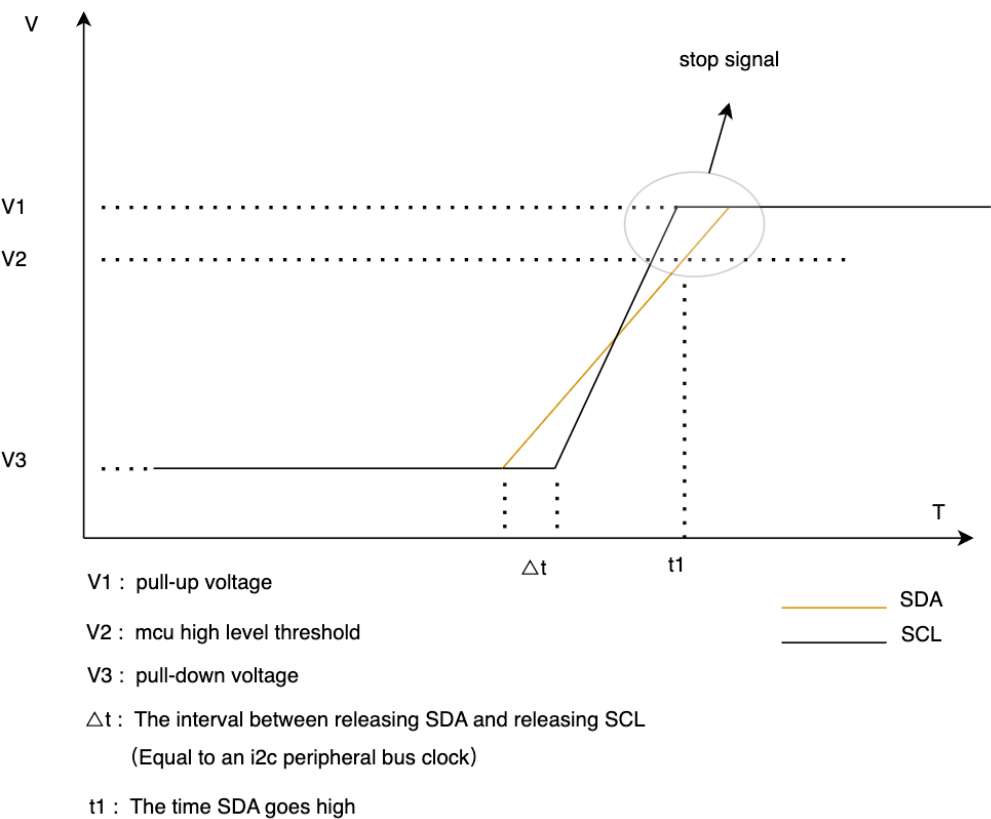
Figure 2: SDA SCL 时序说明

When an I2C module operates as a slave and the TX stall function is enabled, if the master sends a read command and the slave hasn't had time to write data to the TX FIFO, the slave will hold both the SCL and SDA lines low. This state is maintained until the TX FIFO is populated with data. However, if the most significant bit of the data written to the TX FIFO is 1, SDA line will be pulled up, and SCL line will be released after one cycle of I2C peripheral clock, at this time SCL line also will be pulled up. If the rising edge of SDA line occurs during SCL line's high level, it will be considered as a stop signal, which will cause the arbitration failure.

当 I2C 模块作为从机且打开 Tx Stall 功能的时候，主机发送读的命令，从机未来得及往 Tx FIFO 里填写数据，此时从机会将 SCL 和 SDA 线拉低，一直到 Tx FIFO 中被填写数据；若填写的数据最高位为 1，则会将 SDA 线拉高，然后延迟一个 I2C 外设时钟释放 SCL 线，此时 SCL 线会被拉高，如果 SDA 线拉高时的上升沿出现在 SCL 线高电平的时候，那么硬件认为是终止信号，导致仲裁失败，如图所示。
